INITIAL	INSPECTION	OF ANIMAL	FEEDING	OPERATION
TIVI I I I I	MOLECTION	OL WITHING	recome	OFFICIALION

Date of Inspection: 7/17/2019 Primary Inspector: Kaitlyn Steinwart & Cay Ewoldt

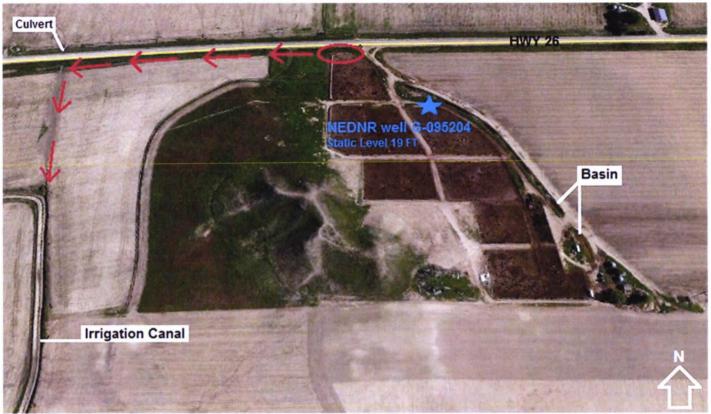
Map #1 IIS: 72636 Date Modified: 8/7/2019 Kaitlyn Steinwart Google Earth Satellite Image The red arrows indicate the path of runoff. The red circle indicates the area where runoff ponds at the base of the pens.

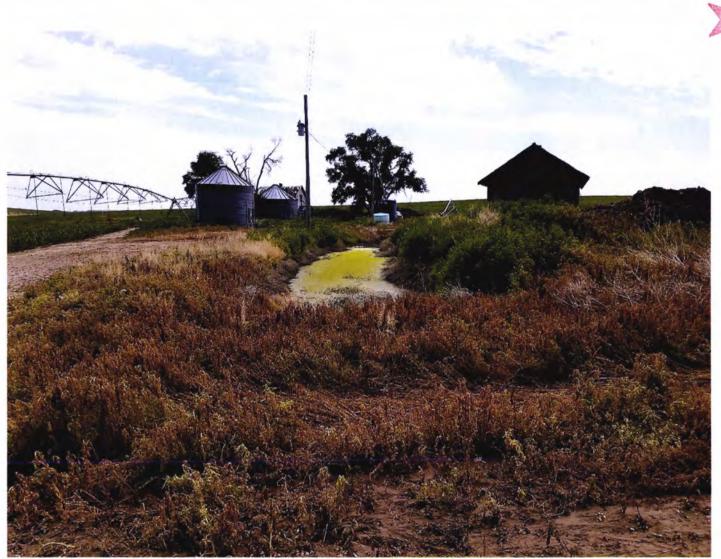
Photo #1 IIS: 72636 Date: 7/17/2019 Kaitlyn Steinwart Samsung Galaxy S7
This photo looks south over a portion of the basin.

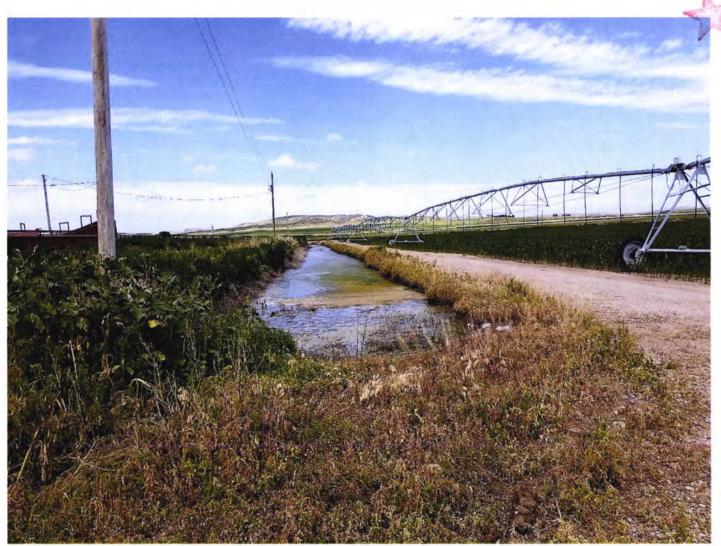
Photo #2 IIS: 72636 Date: 7/17/2019 Kaitlyn Steinwart Samsung Galaxy S7
This photo looks north over a portion of the basin.

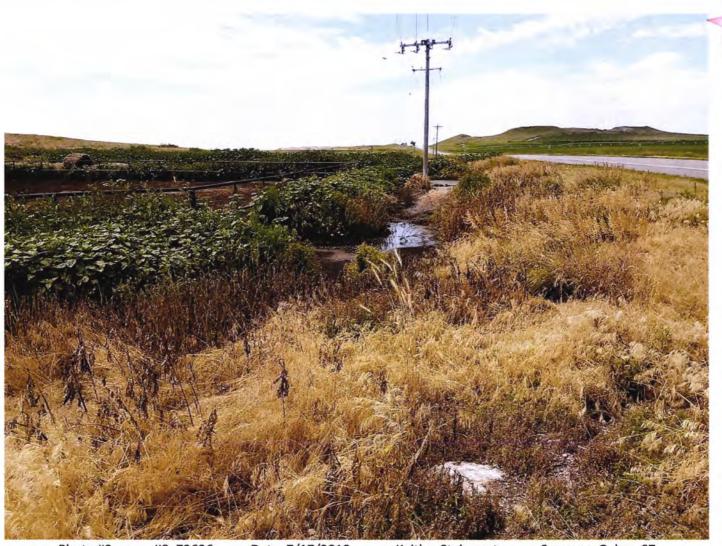
Photo #3 IIS: 72636 Date: 7/17/2019 Kaitlyn Steinwart Samsung Galaxy S7
This photo was taken facing west and overlooks the base of the northernmost pens. Highway 62 can be seen in the upper right-hand side of the photo.

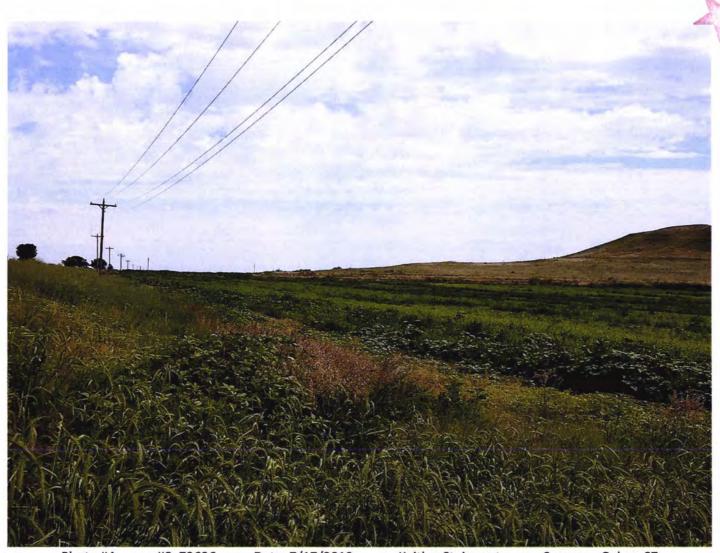
Photo #4 IIS: 72636 Date: 7/17/2019 Kaitlyn Steinwart Samsung Galaxy S7
This photo was taken facing southeast and overlooks the drainage path from the base of the pens to the field, before it turns south.

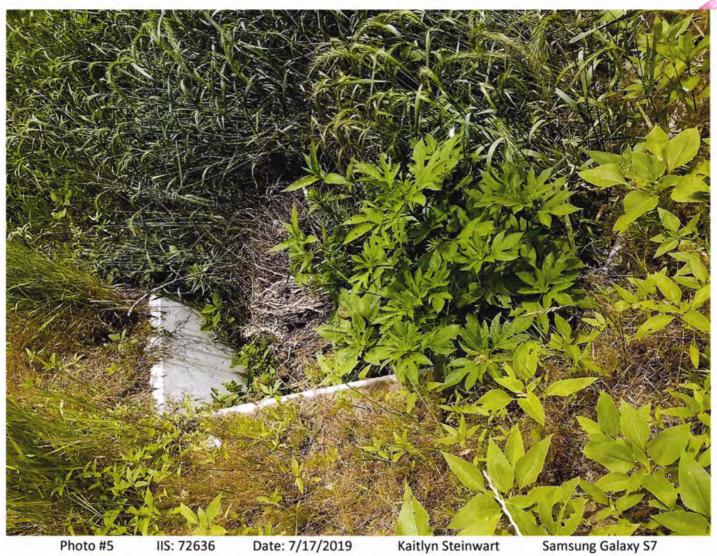
36 Date: 7/17/2019 Kaitlyn Steinwart This photo overlooks the culvert under Highway 62. IIS: 72636 Samsung Galaxy S7

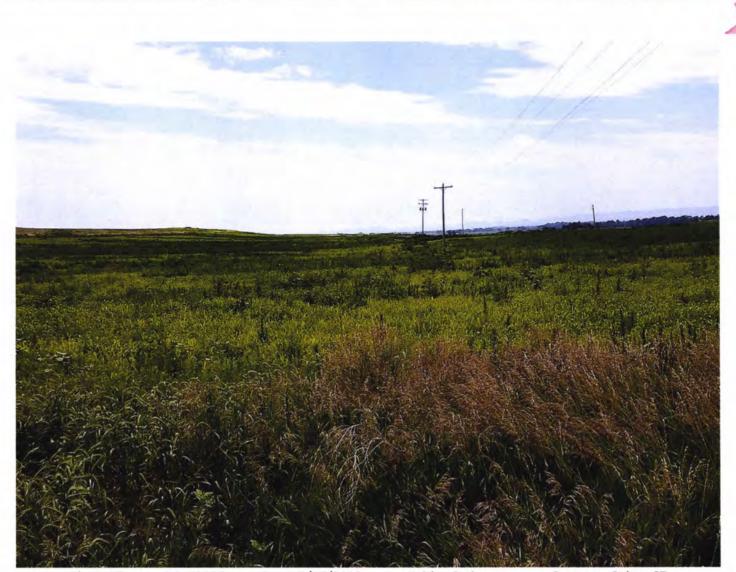
Photo #6 IIS: 72636 Date: 7/17/2019 Kaitlyn Steinwart Samsung Galaxy S7
This photo was taken facing south and overlooks the drainage path through the field and into the irrigation canal.

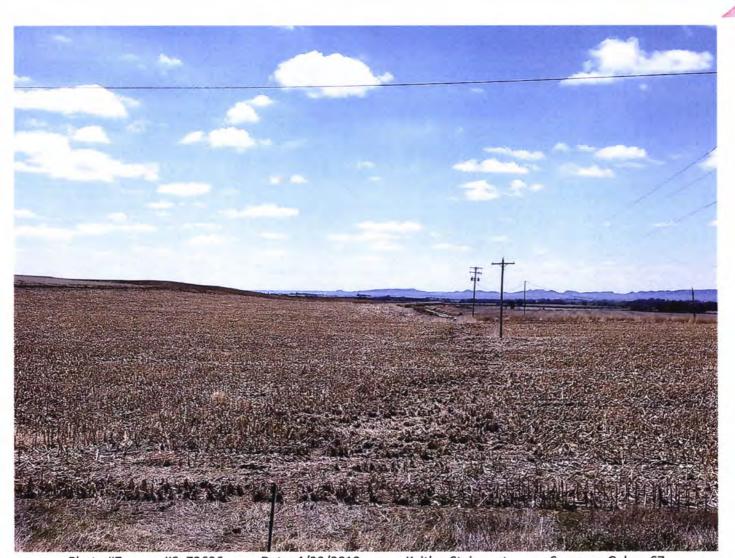
Photo #7 IIS: 72636 Date: 4/23/2019 Kaitlyn Steinwart Samsung Galaxy S7 This photo overlooks the same area shown in Photo #6, but was taken when the drainage was more visible.
